## CAFO WPDES Compliance Report (6-20-14)

Inspection date: 4-25-14

Operation Name: Dairyland Farms LLC

WPDES Permit No. WI-0059559-03-0

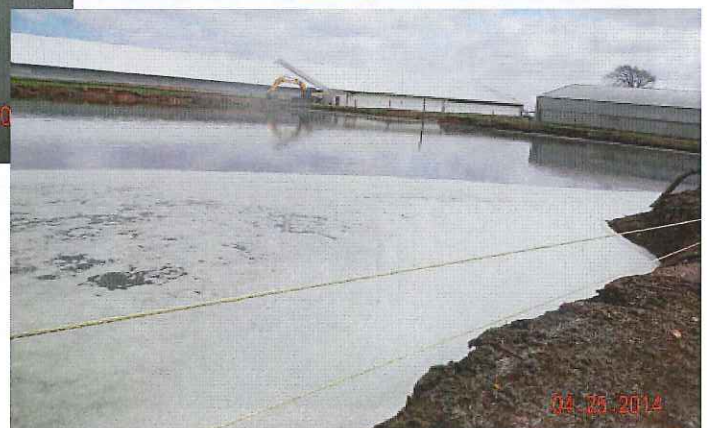
Photo 5 (right): Looking northeast at Home Farm waste storage facility which primarily stores feed storage leachate and runoff.
